Inspection Report

Permit Number:	C0070038
Inspection Type:	COURTESY
Inspection Date:	Monday, November 27, 2006
Start Date/Time:	11/27/2006 2:00:00 PM
End Date/Time:	11/27/2006 2:30:00 PM
Last Inspection:

Permittee: **PLATEAU MINING CORP**

Site: **WILLOW CREEK MINE**

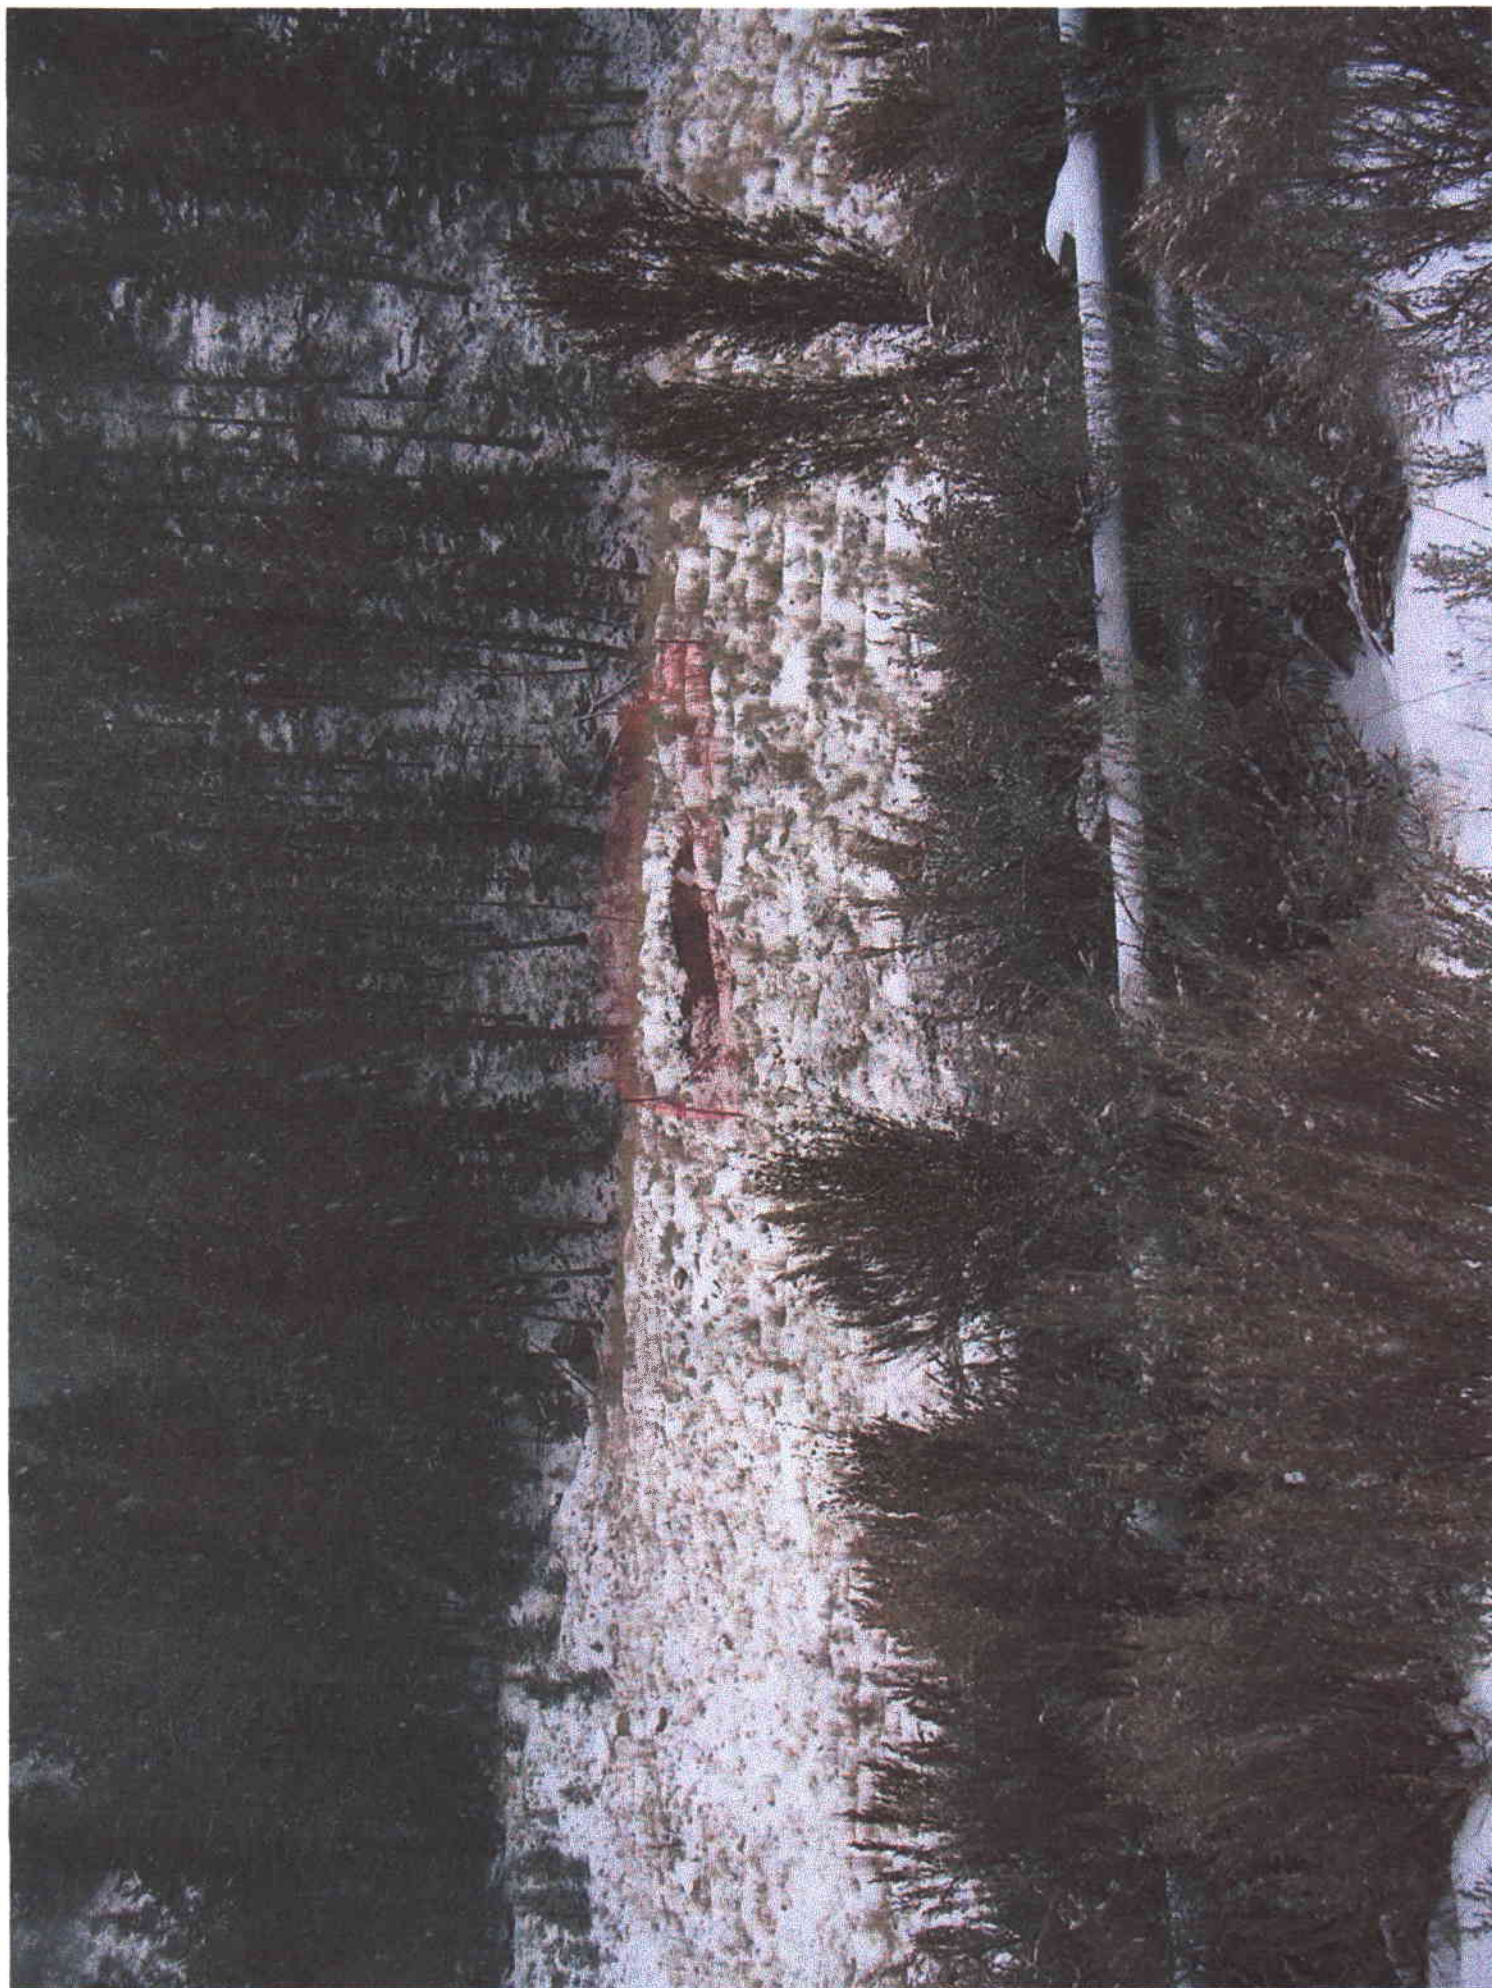
A void exists in the location of Shaft No. 2 at the reclaimed Crandall Canyon site. The opening is estimated at 20 ft X 200 ft. An unknown depth of water is in the bottom of the shaft. The Permittee requested a site visit with a contractor, the BLM, and DOGM to determine a course of action.

Met with Dennis Ware, Mark Greenhough (Nielson Constr.), Steve Rigby, Steve Faulk, and Sue Berger at the site. The problem is with Shaft No. 2 at the downstream end of the site. A void recently reopened around the shaft collar (see photo attached).

According to the MRP Sec. 3.7, the shaft intercepts both the D-seam and the lower Sub 3 seam (No. 3 mine). Groundwater was encountered in both of these seams. The groundwater level in 2002 was 5785 ft. in shaft No. 2 (at the elevation of the D-Seam (No. 5 mine)). Construction of this shaft also intercepted subsurface drainage approximately 30 - 60 ft below the surface at the interface of unconsolidated soils and bedrock. During construction, this subsurface flow was grouted and reduced to 10 gpm. The No. 2 shaft is concrete-lined.

Recent reclamation of the 1,457 ft. deep shaft in 2003 involved backfilling the opening to an elevation above the known water level in the D-Seam (#5 mine), adding a layer of boulders and then topping with a layer of bentonite.

An orange fence currently surrounds the shaft opening. The fill has caved to the extent of the cement collar. The depth to water in the shaft was estimated at 200 ft, based upon the length of time a rock took to hit water in the shaft. The Permittee proposes to backfill the 20 ft X 200 ft hole with the surrounding soil which was intentionally mounded in a concave fashion around the shaft. The work will be done this week. The final graded surface will be seeded. A Division hydrologist should review this proposed plan of action.
